Advanced Composite Vertical Fin
for L-1011 Aircraft

*Design, Manufacture, and Test
(Executive Summary)*

A. C. Jackson

CONTRACT NAS1-14000
SEPTEMBER 1984

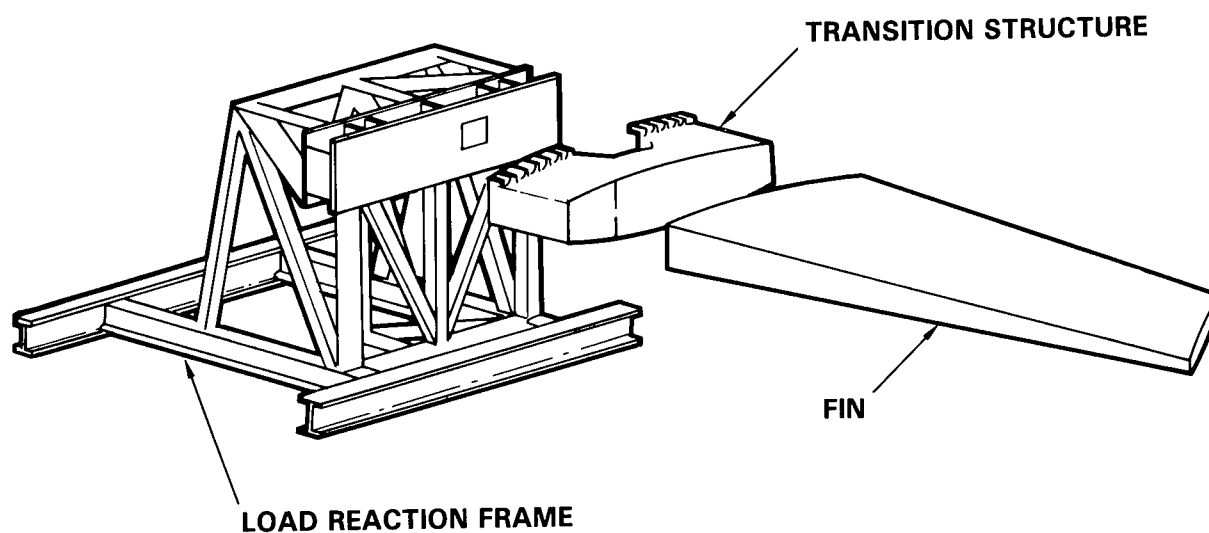
Figure 27. - Test installation of fin in load reaction frame.

The fin and transition structure were attached to the load reaction frame in a horizontal attitude as shown in figure 27.

Externally applied side loads were introduced to the fin along the length of the front and rear spars from jack-trains which were mounted on the floor. Fore- and aft-direction external loads were applied to the fin through the rudder actuator retention brackets.

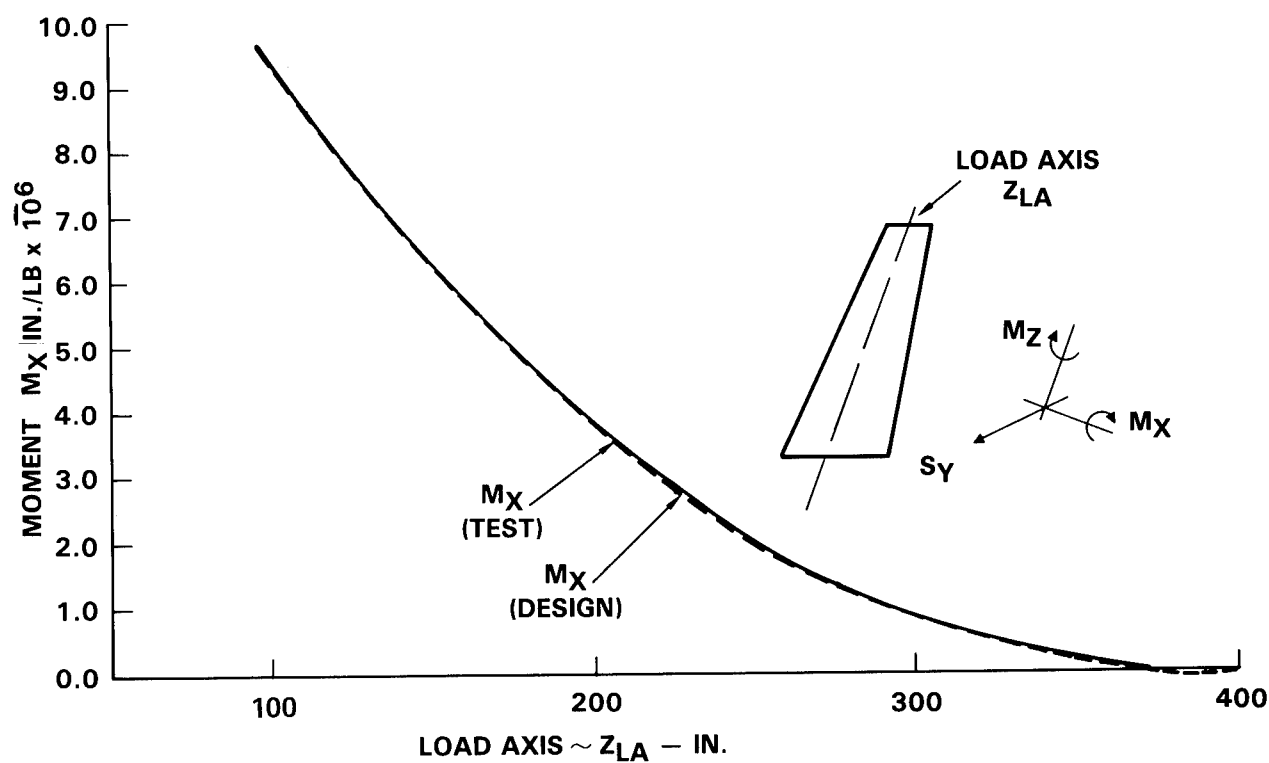
Figure 28. - Test bending moment compared with design bending moment.

The ground test article (GTA) was tested with static loads simulating a high bending dynamic lateral gust condition. This condition was critical for the front spar and covers and adequately loaded the whole structure. A comparison of the design and test bending moments is shown in figure 28. A factor of 1.06 was applied to the loading to account for environmental effects as the tests were conducted at ambient temperature and moisture levels.
